SIKA AT WORK

CONDUCTOR REPAIR FOR GAS FIELD COMPLEX, OFFSHORE SARAWAK, MALAYSIA

OFFSHORE & MARINE CONSTRUCTION
CONVENTIONAL ENERGY

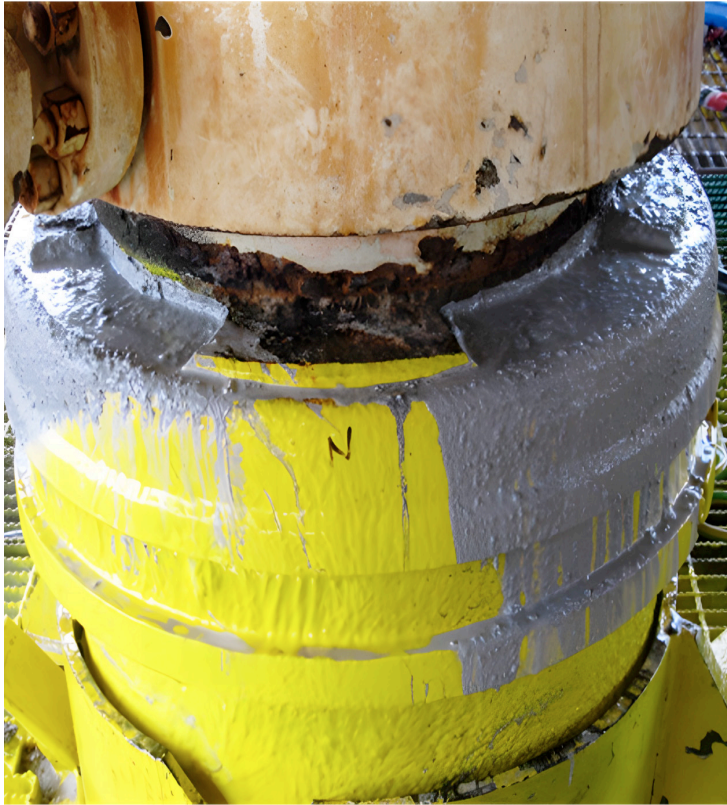
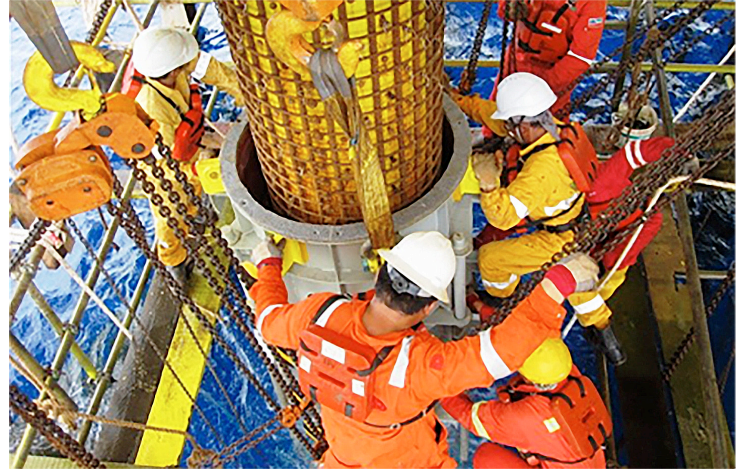
In March 2012, Sika worked in collaboration with Sarawak Shell Sdn. Bhd. to carry out structural reinstatement and corrosion repair of a conductor on an offshore platform in the Sarawak gas field. The conductor, located in the splash and tidal zones, exhibited severe corrosion that compromised its structural performance and exposed the inner casing to further degradation.

The 26-inch conductor had corroded extensively, with suspected damage also affecting the 18 5/8-inch inner casing. In this condition, well loads were being redistributed across the remaining intact casings, raising the risk of structural failure. The client required a durable, diver-free repair that could restore bending and shear capacity across the affected zone while minimizing offshore equipment footprint and avoiding hot-work operations.

Sika provided a full-service well integrity solution using Ultra-High-Performance Concrete (UHPC) grout and a custom-designed formwork system. The repair involved the installation of vertical steel rebars to restore bending resistance, with shear studs included to ensure effective shear transfer between the conductor and the repair material.

Prior to installation, marine growth was removed using ultra-high-pressure water jetting to ensure clean bonding surfaces. The prefabricated mold was then installed from the bottom of the spider deck to -4 meters below mean sea level. All work was carried out from the platform's main deck, with no divers required.

The UHPC grout was injected into the formwork to fully encapsulate the conductor and inner casing. Due to the rapid strength development of the UHPC, the formwork was safely removed just 24 hours after casting. The repair method and structural behavior were validated using Finite Element Modelling (FEM) analysis.
