STRENGTHENING AND CORROSION PROTECTION OF STRUCTURAL CASING OF WELLS, SARAWAK, MALAYSIA

OFFSHORE & MARINE CONSTRUCTION
CONVENTIONAL ENERGY

Project name: Strengthening and Corrosion Protection of Structural Casing of Wells
Client: Sarawak Shell Berhad
Location: Offshore Sarawak, East Malaysia
Year: 2017
Application: Well integrity
Product: A predecessor of SikaGrout®-9550

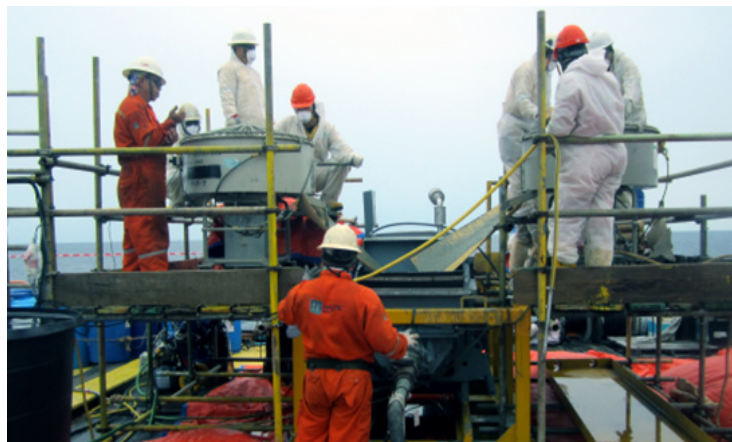
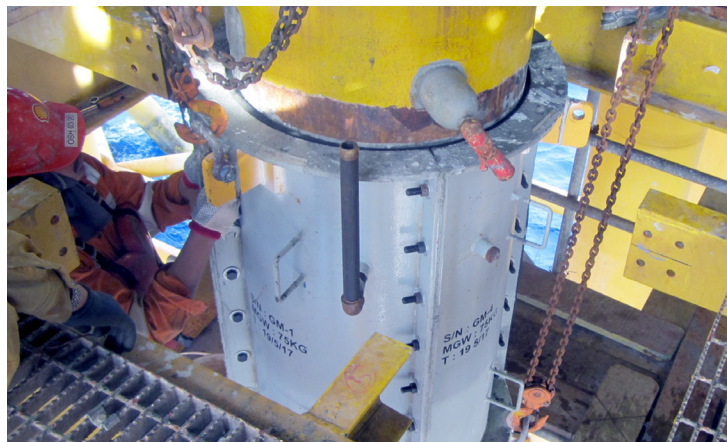
In mid-2017, Sika was engaged by Sarawak Shell Berhad to strengthen and repair two corroded wellhead conductors on one of its offshore platforms in East Malaysia. Visual inspections had revealed significant corrosion and deterioration in the surface casings of two wells, prompting immediate intervention to arrest the degradation and restore structural performance.

Corrosion in the splash zone and upper annular regions of the wells posed a threat to both the long-term operability and structural safety of the platform. The client required a permanent strengthening and sealing solution that could restore full load transfer capability between the well casing and conductor, while protecting the repaired zone from further corrosion and chemical attack.

Sika carried out a pre-job visual inspection to assess the condition of the conductor casings, the extent of rust and perforations, and any existing blockages within the annulus. The damaged concrete was broken and removed from inside the annulus to prepare for infill grouting. Rebar cages and prefabricated mould sections were installed around each well conductor to facilitate structural reinforcement.

Sika then supplied and injected 4 metric tons of its proprietary ultra-high performance cementitious (UHPC) grout material, developed specifically for structural repairs in marine environments. The material's dense matrix, extremely low permeability, and exceptional bond characteristics made it ideally suited to both strengthening and corrosion protection.
