SIKA AT WORK

MM-17 WELL CONDUCTOR REPAIR, OFFSHORE BRUNEI

OFFSHORE & MARINE CONSTRUCTION
CONVENTIONAL ENERGY

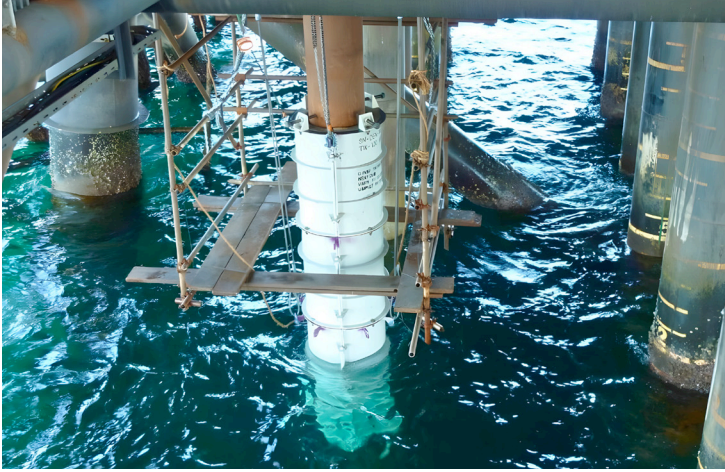
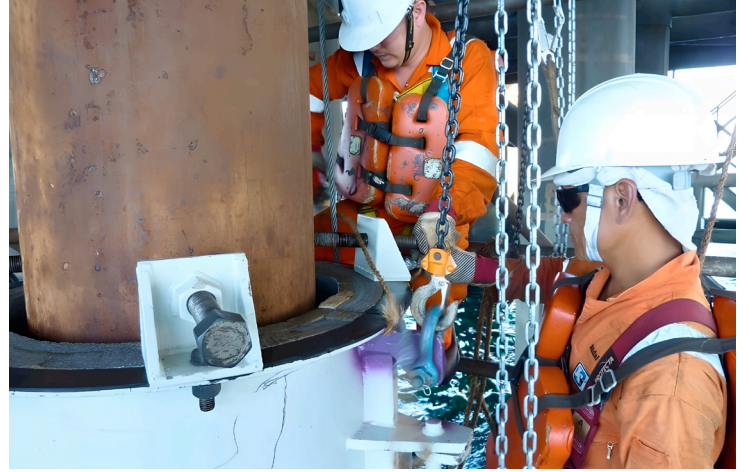
In October 2012, Brunei Shell Petroleum engaged Sika to carry out well integrity services on the MM-17 well conductor, located on the MMDP-01 platform offshore Brunei. The 24-inch conductor, located in the splash zone, exhibited external corrosion and required structural reinforcement and protection.

The conductor had experienced localized corrosion in the splash zone, raising concerns about ongoing exposure and structural capacity. A fast, diver-free repair solution was needed to encapsulate and strengthen the conductor in-situ without the need for hot work or extended downtime.

Sika supplied 3 metric tons of ultra-high-performance cementitious grout, specially selected for its rapid strength gain and excellent bonding properties in splash zone environments. A bespoke external clamp was designed by Sika's engineering team, incorporating a tailored opening and closing mechanism that allowed installation without diver support.

Scaffolding was erected from the platform to access the repair area, enabling clamp installation at approximately 2 meters below mean sea level. Prior to grouting, marine growth was removed to ensure clean bonding surfaces. The annular space between the clamp and conductor was then grouted from 2 meters below to 2 meters above MSL to fully encapsulate the corrosion zone.

The grout achieved approximately 50% of its long-term strength within 24 hours, allowing the clamp to be safely removed the next day and minimizing offshore duration.
