## LIBRO PLATFORM AND CONDUCTOR INTEGRITY STRENGTHENING, PHILIPPINES

OFFSHORE & MARINE CONSTRUCTION  
CONVENTIONAL ENERGY

Project name: Libro Platform and Conductor Integrity Strengthening  
Client: The Philodrill Corporation  
Location: Offshore Philippines  
Year: 2018  
Application: Well integrity, repair and maintenance  
Product: A predecessor of SikaGrout®-9550, SikaGrout®-9970

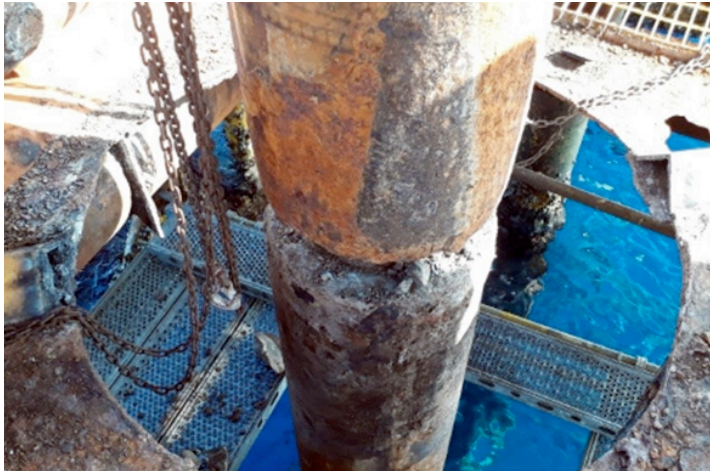
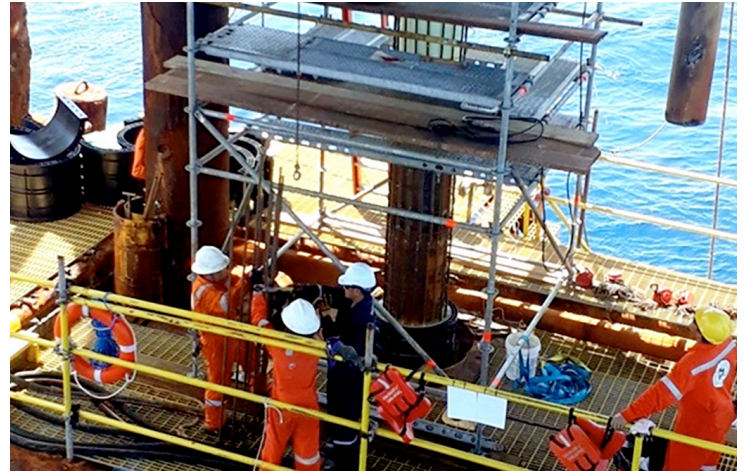
The client required a targeted repair solution that would restore the structural capacity of the platform and seal leaking conductor sections in preparation for P&A. Visual inspections revealed extensive corrosion across the platform and multiple leak points along the conductor, including a parted section near the spider deck. The challenge was to deliver a robust and reliable solution capable of meeting pressure containment and structural performance requirements with minimal offshore disruption.

To restore the conductor's pressure containment capability, Sika installed a 10-meter UHPC sleeve using SikaGrout®-9970. The repair included vertical and circumferential reinforcement bars to reestablish structural integrity. For added protection and sealing, additional works were carried out using a predecessor of SikaGrout®-9550 to perform infill grouting on a knee brace between the cellar and top decks.
