SIKA AT WORK

SMDP-B PLATFORM CONDUCTOR REPAIR, LABUAN, MALAYSIA

OFFSHORE & MARINE CONSTRUCTION
CONVENTIONAL ENERGY

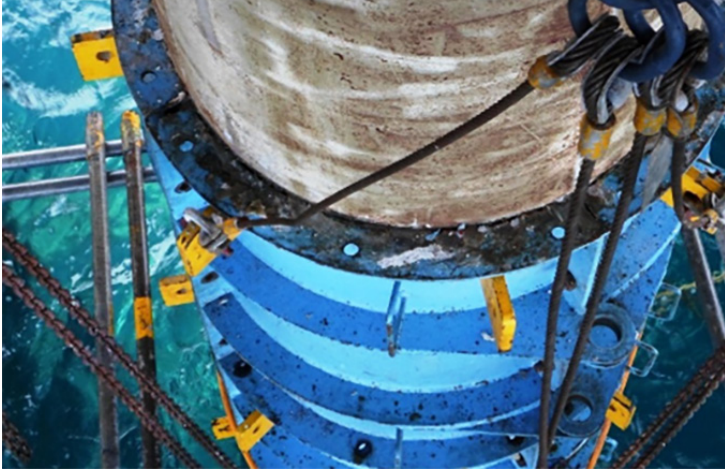
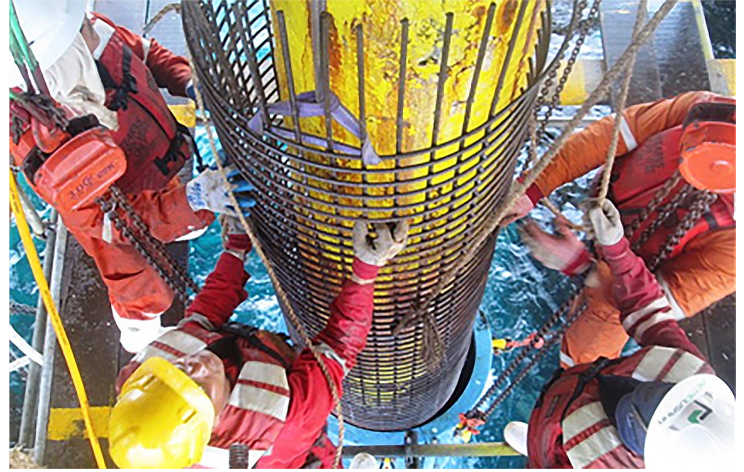
In September 2012, Sika worked alongside PetroUsaha Engineering Services Sdn. Bhd. to carry out the structural reinstatement of five conductors on the SMDP-B platform at the Samarang Oilfield, offshore Labuan, Malaysia. The conductors exhibited significant corrosion, particularly in the splash zone, compromising both their structural capacity and the integrity of the inner casing.

With visible corrosion on the outer conductors and exposure of the internal casings, the risk of structural failure was high. The client required a diver-free solution to restore strength and protect the conductor assemblies from further degradation.

Sika supplied 64 metric tons of SikaGrout®-9970, a UHPC material specifically engineered for offshore structural repairs. To restore structural performance, vertical steel rebars were installed along each conductor to reinstate bending moment capacity. The rebar cage also met minimum requirements for crack control within the grout.

Before grouting, marine growth was removed using ultra-high-pressure water jetting and Barracuda cleaning tools to ensure full bonding between the grout, steel rebars, and conductor surface.

Each conductor was encapsulated in a custom-designed external mould, which extended from the spider deck to 3 meters below mean sea level. The repair was executed without diver involvement, with all works conducted from the platform deck.

Once in place, the grout was injected into the moulds to encapsulate the conductors and casings, restoring their full structural design strength and providing long-term corrosion protection.
